DEXON CANADA AIR SYSTEMS INC.

TROUBLE SHOOTING GUIDE for MDV2 & MDVIL2 VENT FANS

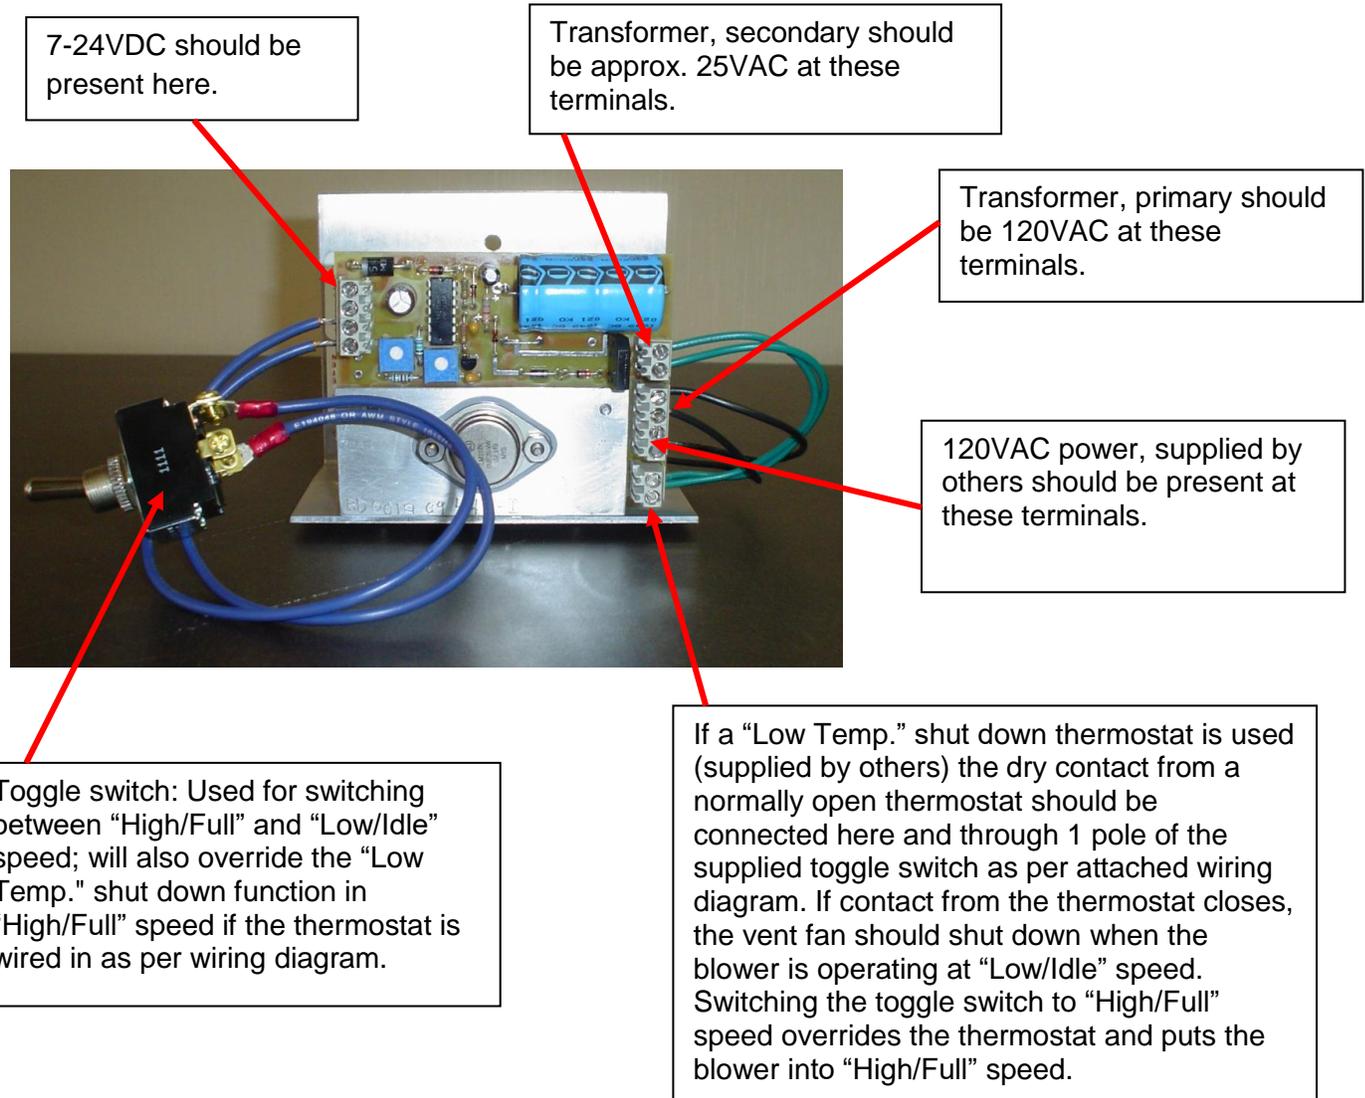
POWER SUPPLY/SPEED CONTROLLER DESCRIPTION

Note: Description below is assuming the power supply/speed controller is energized.

Problem	POSSIBLE CAUSE	CORRECTIVE ACTION
Vent fan not operating.	No 120VAC power to the power supply/speed controller.	Check for 120VAC at TB3 as per wiring diagram. If not present, check power source and fuses etc. Ensure the power supply/speed controller is energized.
	No 7-24VDC power present at TB5 on power supply/speed controller.	Disconnect blower wires at TB5 and check again for 7-24VDC. If still none, check transformer secondary at TB2 for 24VAC. If none, replace the transformer. If 24VAC is present from the transformer and still no 7-24VDC at TB5 then replace the power supply/speed controller.
	No 7-24VDC power present at terminal block inside vent fan housing.	If 7-24VDC is present at TB5 on the power supply/speed controller but not in the vent fan housing; check wiring and connections and rectify as required.
	Blower has expired or wiring terminals are corroded and/or broken.	De-energize 120VAC to power supply/speed controller; remove louver section, check that the blower spins freely, check wiring and connection pins. Replace blower as required.
